# Software House

## C•CURE 9000 Technical Advisory Bulletin

**TAB number:** SWH-TAB-000036444

**Topic:** iSTAR Web Page Diagnostic Utility issue on Google Chrome and Microsoft Edge

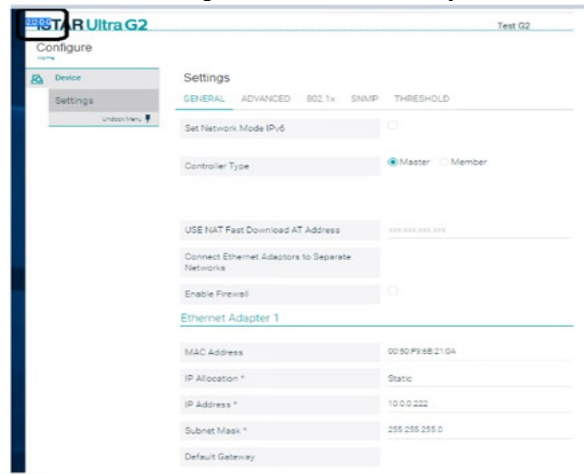
Figure 2: Default Gateway field

1. On the Settings page, click Edit and then click in the Subnet Mask field. On your keyboard, press the Tab key. The Default Gateway field displays in the top left of your web browser, as shown in Figure 2 below. Enter the Gateway IP address, press the Tab key, and then click Save. The Gateway IP address is saved but the field is still blank.

2. Use a different browser, such as Mozilla Firefox.
3. Revert to an earlier version of Google Chrome or Microsoft Edge.

SPAR 862681 will resolve this issue and will be released as part of firmware version 6.9.2 CU01.
